National Register of Historic Places Registration Form

historic name Henry County Savings Bank
other names/site number _____

street & number 100 S. Main not for publication
city, town Mount Pleasant vicinity
state Iowa code IA county Henry code 087 zip code 52641

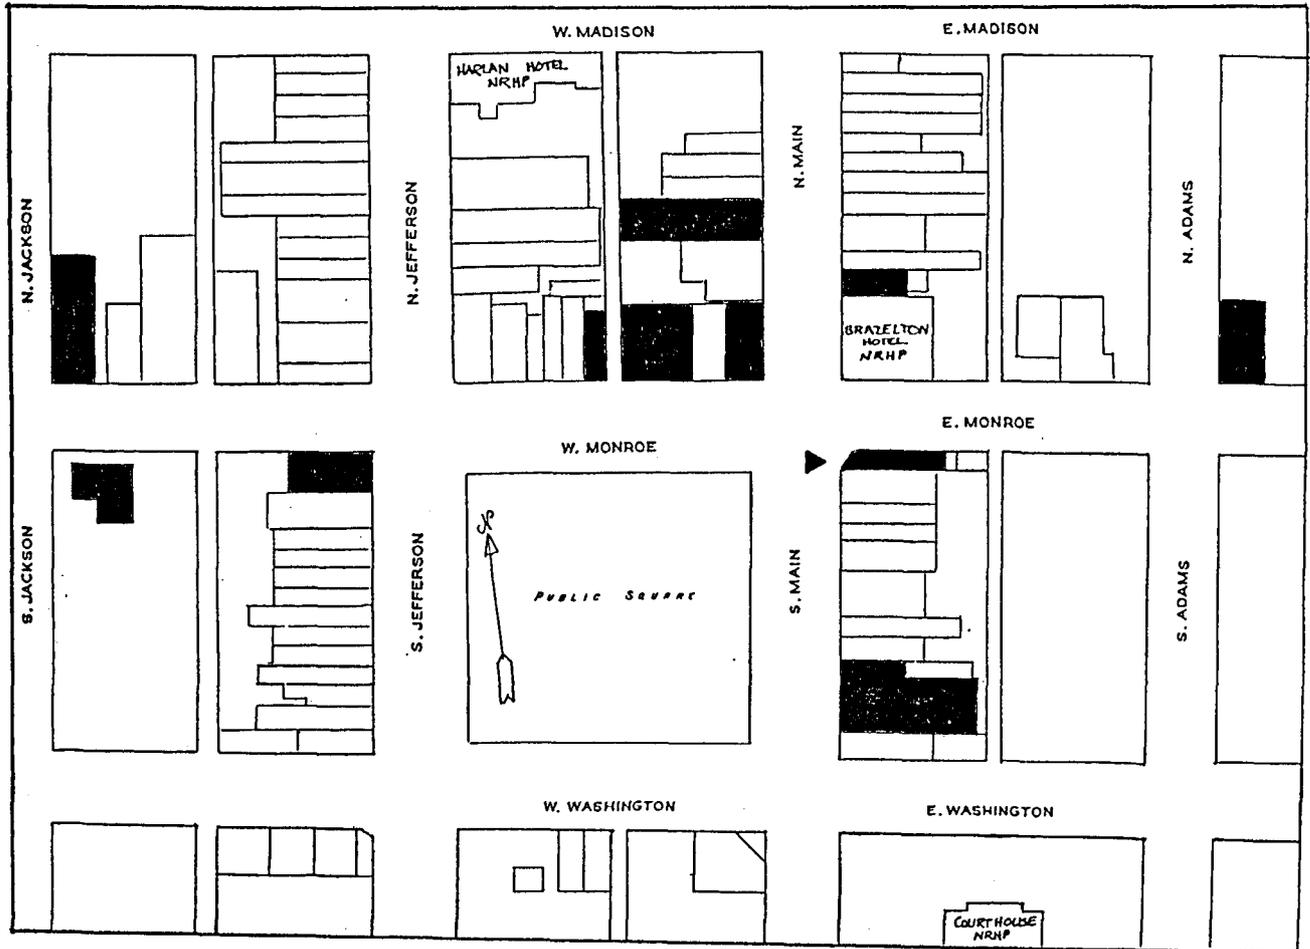
MOUNT PLEASANT PUBLIC SQUARE

Shaded buildings are those being nominated.

▶ indicates specific building being nominated.

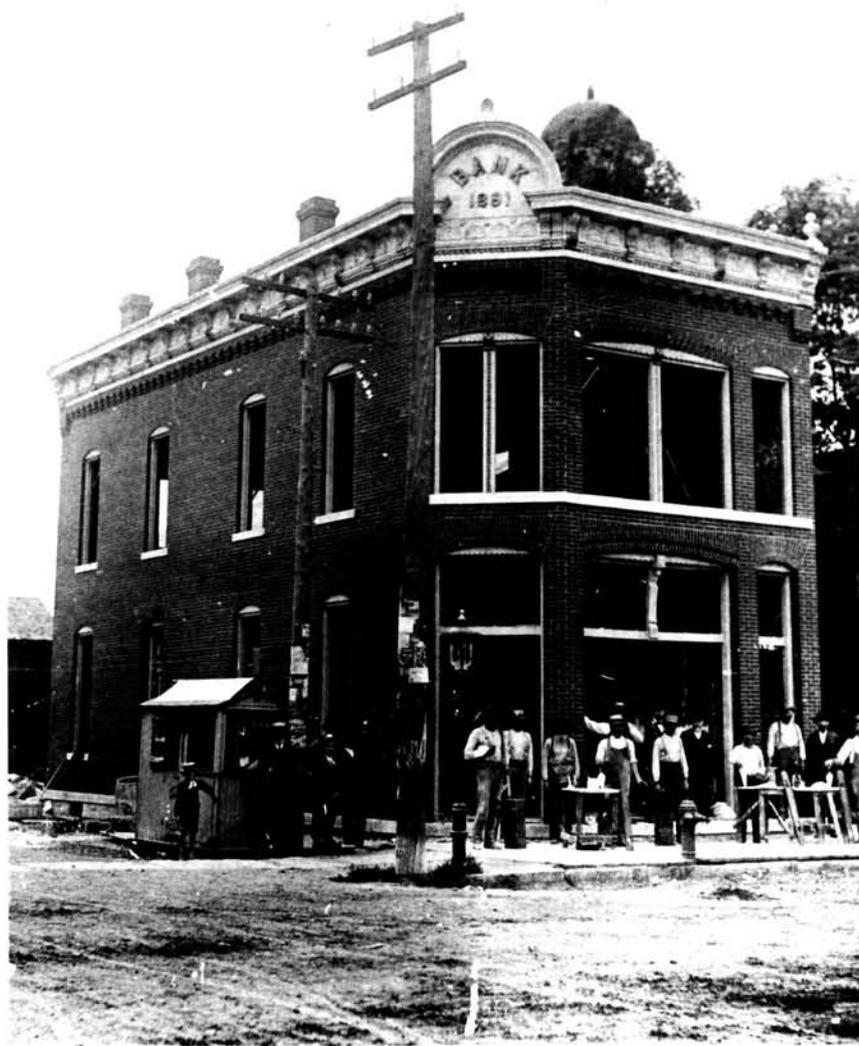
Henry County Savings Bank
100 S. Main
Mt. Pleasant, Ia
Historic photo - 1891
Shows bldg during construction
2/4

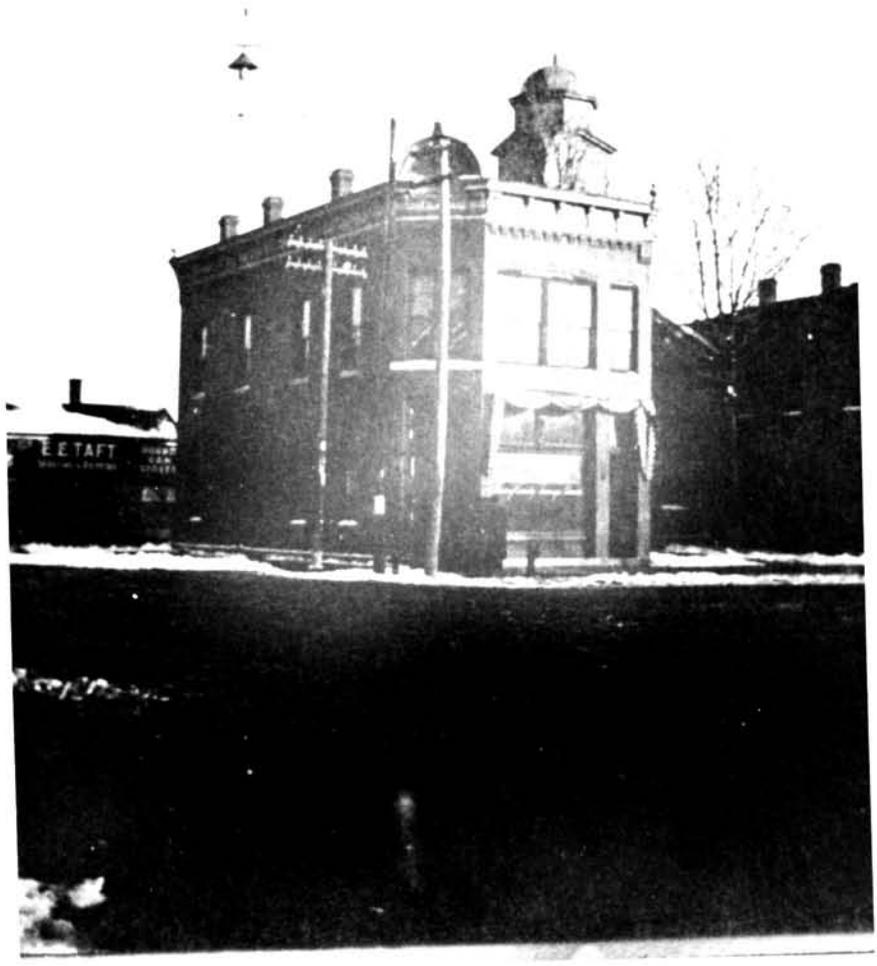
Henry County Savings Bank
100 S. Main
Mt. Pleasant, Ia
Historic photo, c 1895-1900
3/4 view to SE - note Congregational Church tower
#5
