National Register of Historic Places Registration Form

historic name Timmerman-Burd Building
other names/site number _____

street & number 118 S. Main not for publication
city, town Mount Pleasant vicinity
state Iowa code IA county Henry code 087 zip code 52641

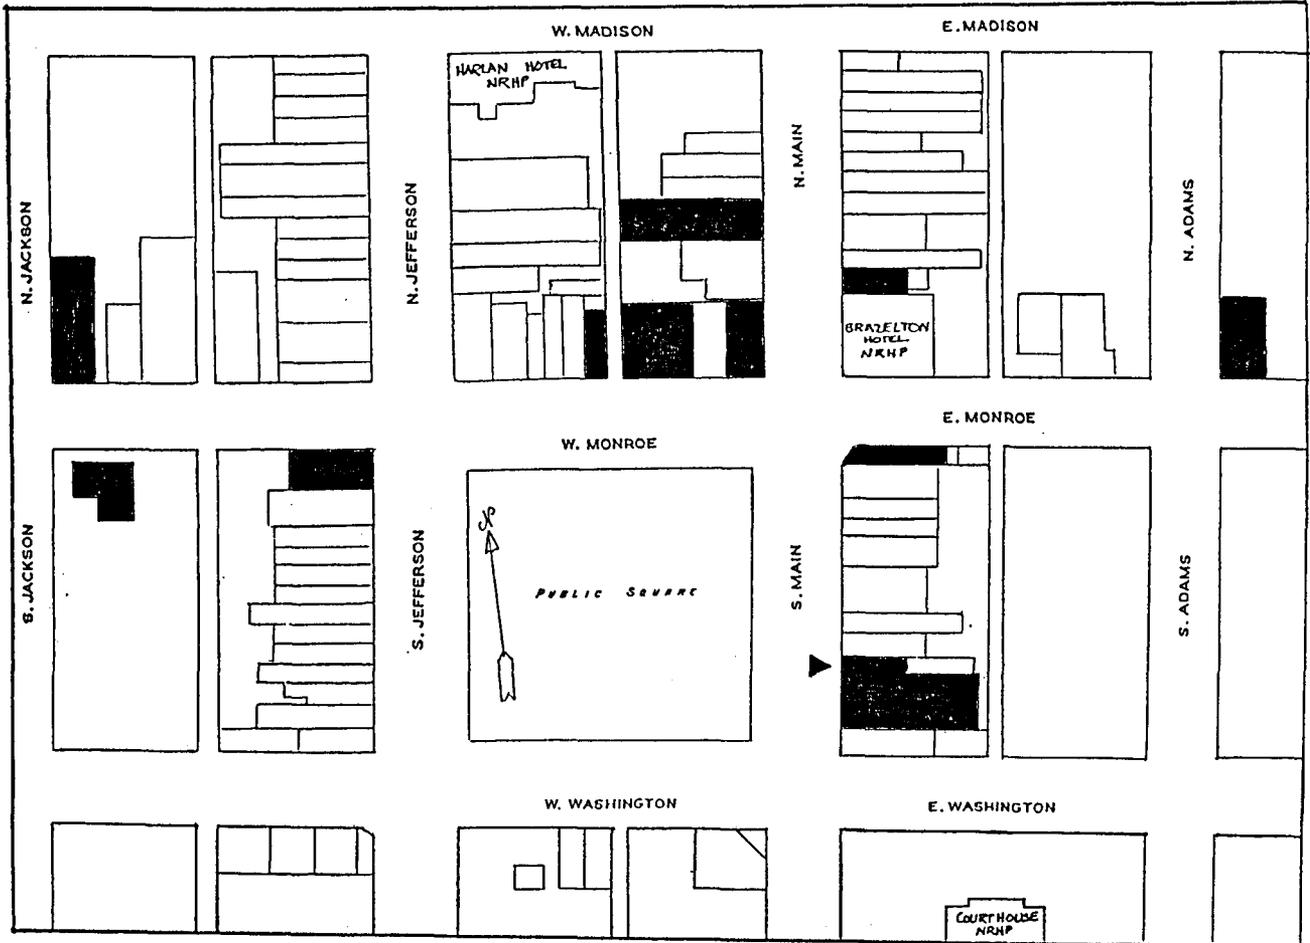
MOUNT PLEASANT PUBLIC SQUARE

Shaded buildings are those being nominated.

▶ indicates specific building being nominated.

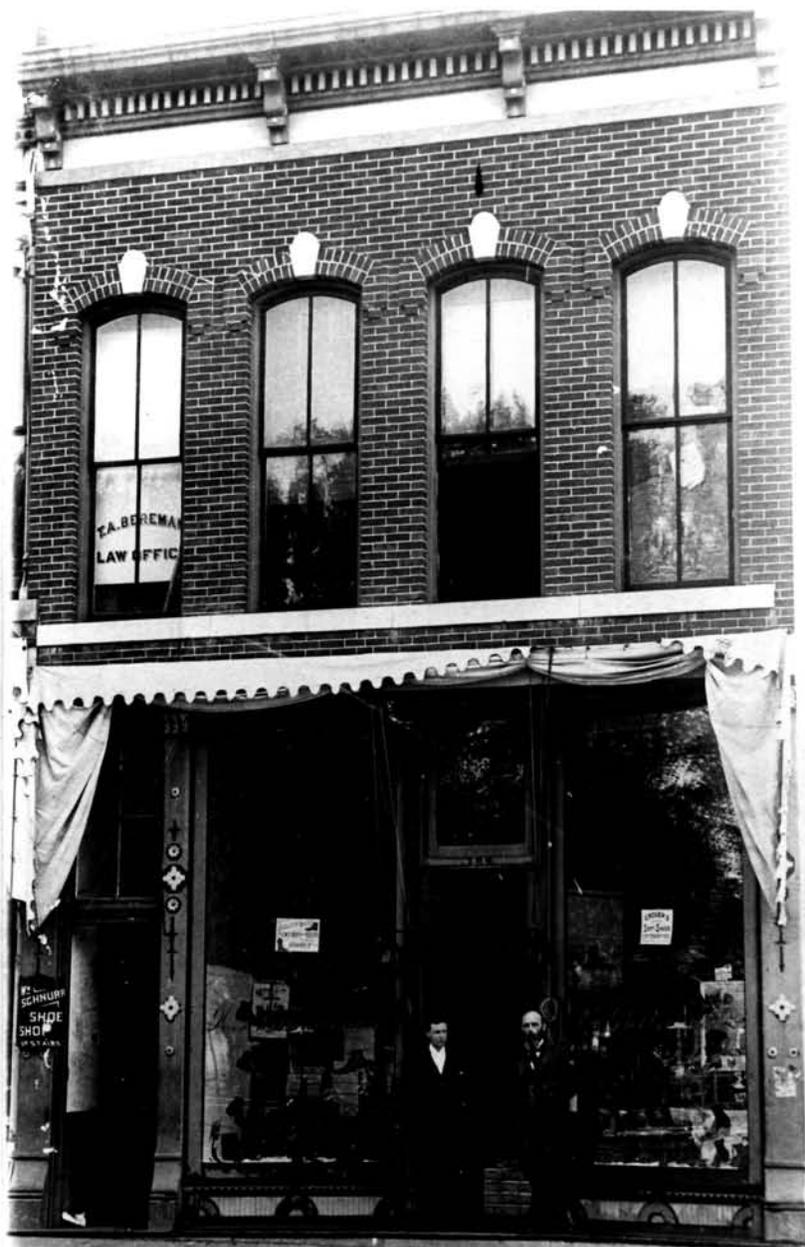
Timmerman - Sward Bldg
118 S Main
Mt. Pleasant, Ia
Historic Photo - 1892
Facade w/ Henry Timmerman's Employee
#2

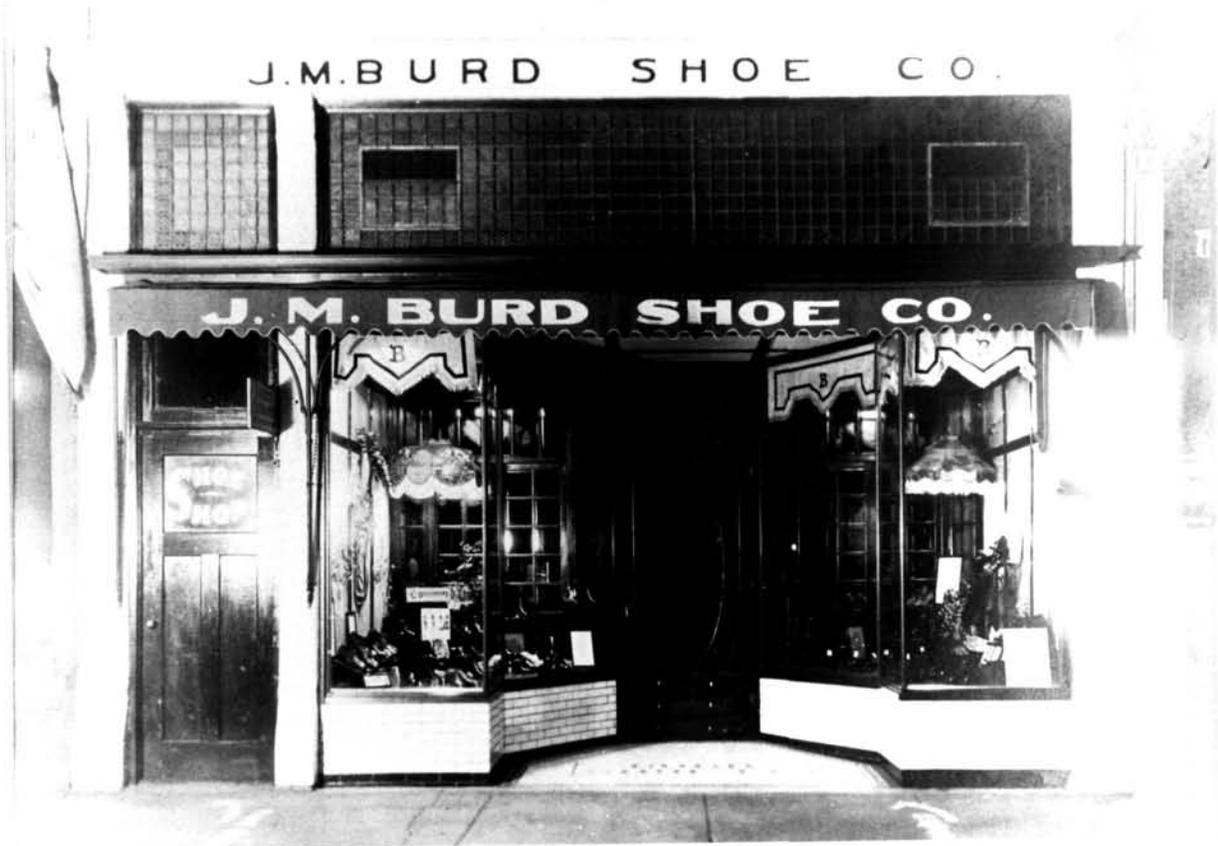
#4

Historic Photo: 1920

First Floor Facade w/J. M. Bard signs & entry
