National Register of Historic Places Registration Form

historic name Zuhn Building
other names/site number _____

street & number 201 E. Monroe not for publication
city, town Mount Pleasant vicinity
state Iowa code IA county Henry code 087 zip code 52641

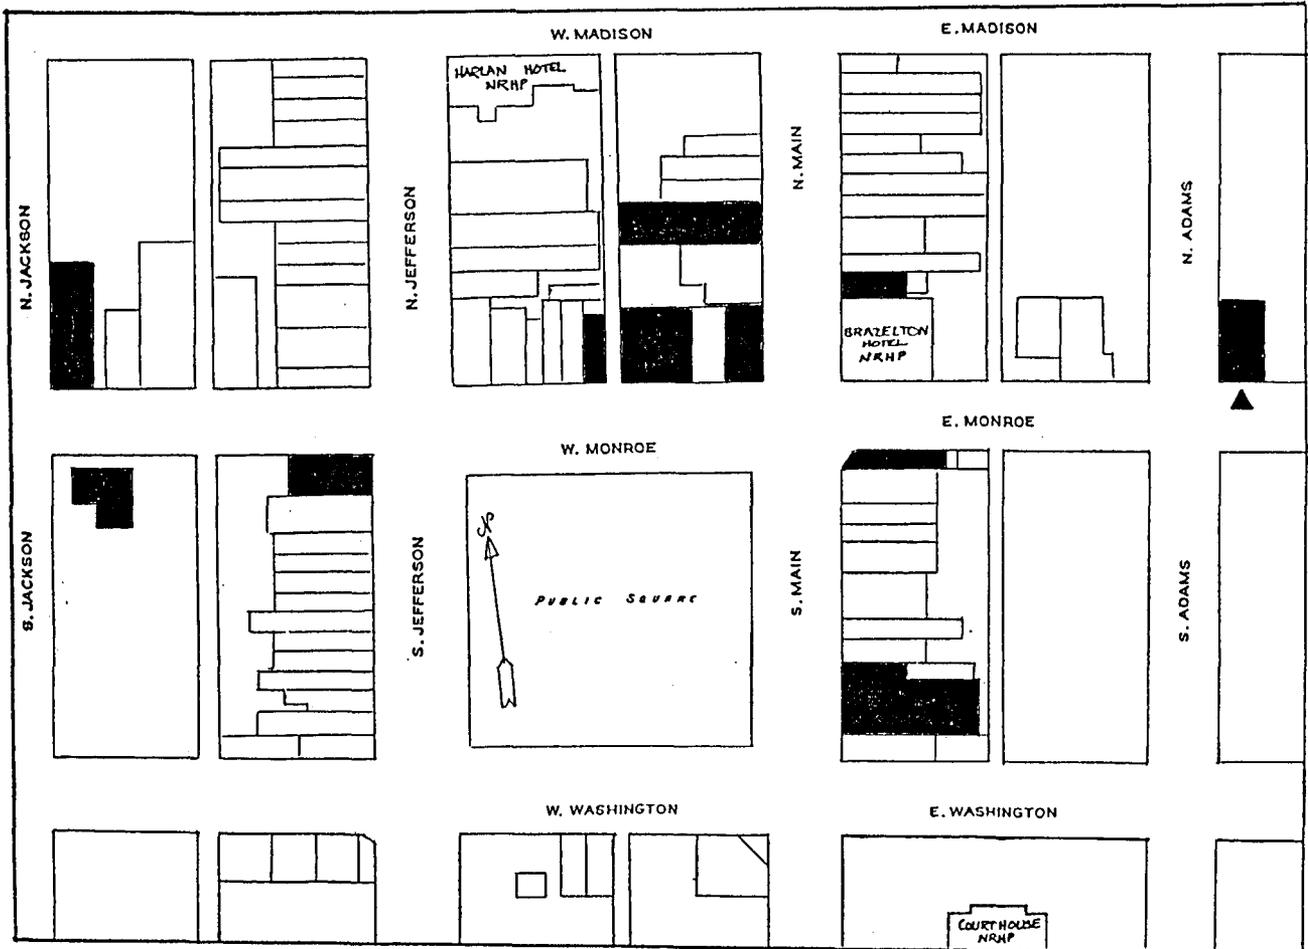
MOUNT PLEASANT PUBLIC SQUARE

Shaded buildings are those being nominated.

▶ indicates specific building being nominated.
