National Register of Historic Places Registration Form

historic name National State Bank
other names/site number _____

street & number 101 W. Monroe not for publication
city, town Mount Pleasant vicinity
state Iowa code IA county Henry code 087 zip code 52641

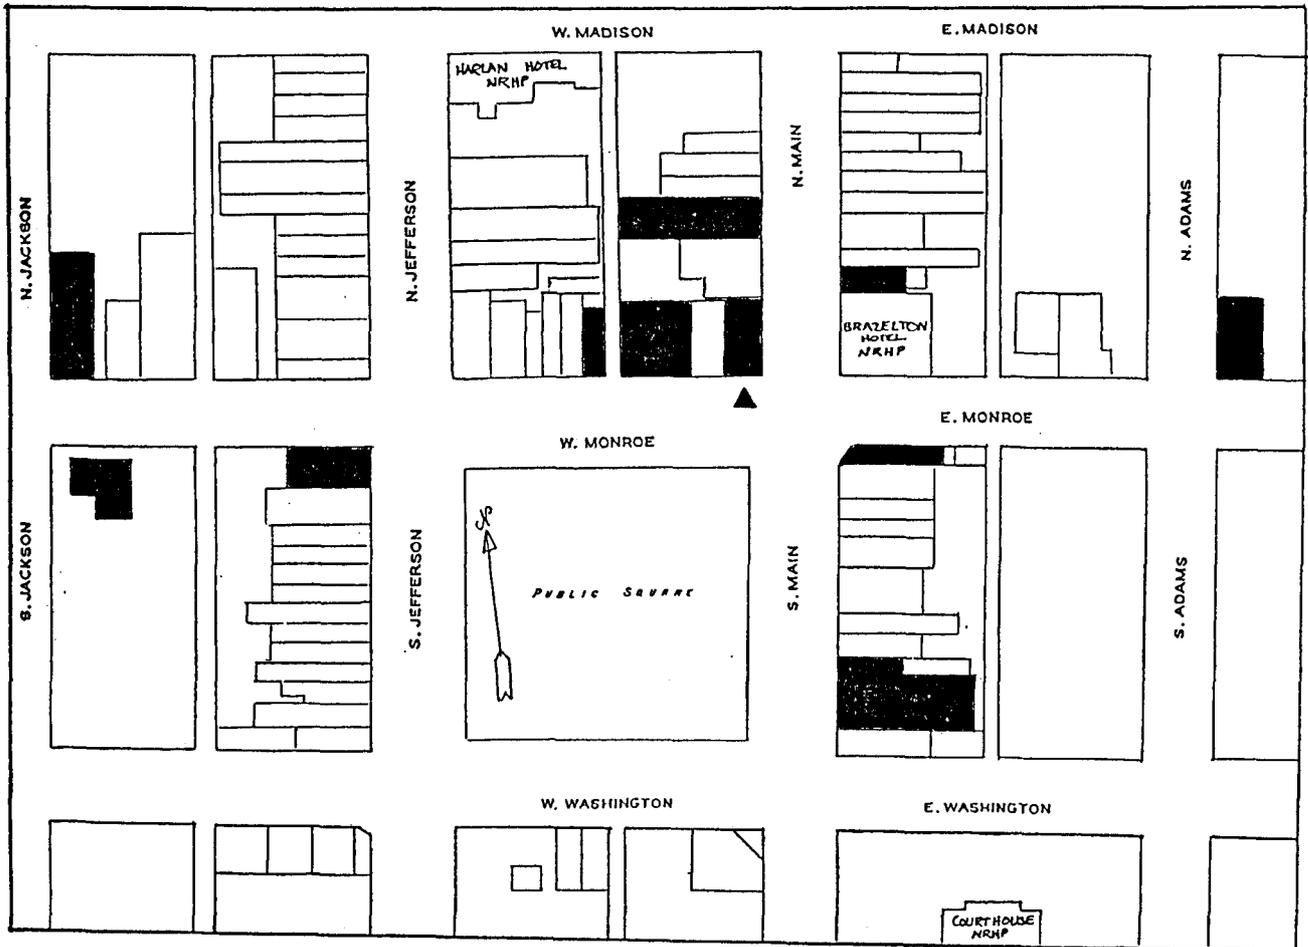
MOUNT PLEASANT PUBLIC SQUARE

Shaded buildings are those being nominated.

▶ indicates specific building being nominated.

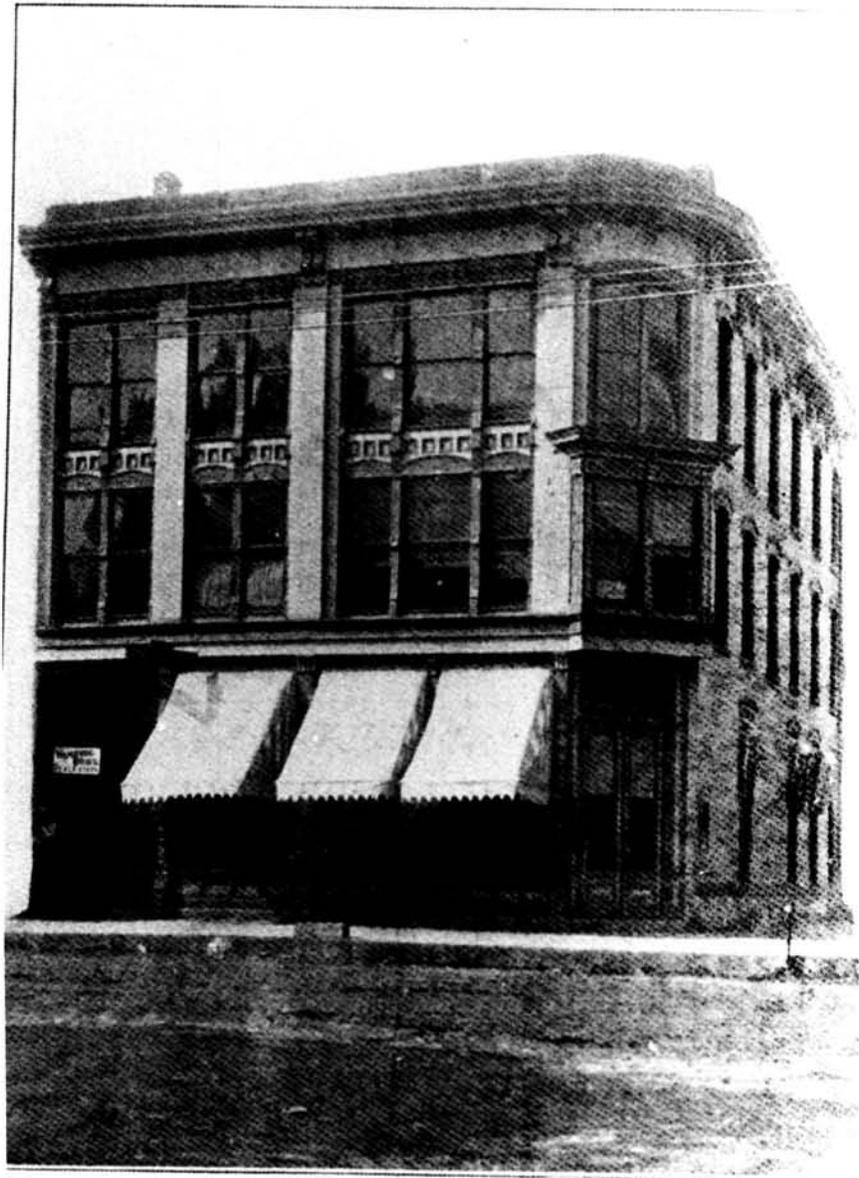
#-1

NATIONAL STATE BANK

HISTORIC PHOTO FROM 1909

VIEW OF FACADE TO NNW
