National Register of Historic Places
Registration Form

historic name Cooper, George and Margaret, House

other names/site number The Cooper House

street & number 400 West Monroe N/A not for publication

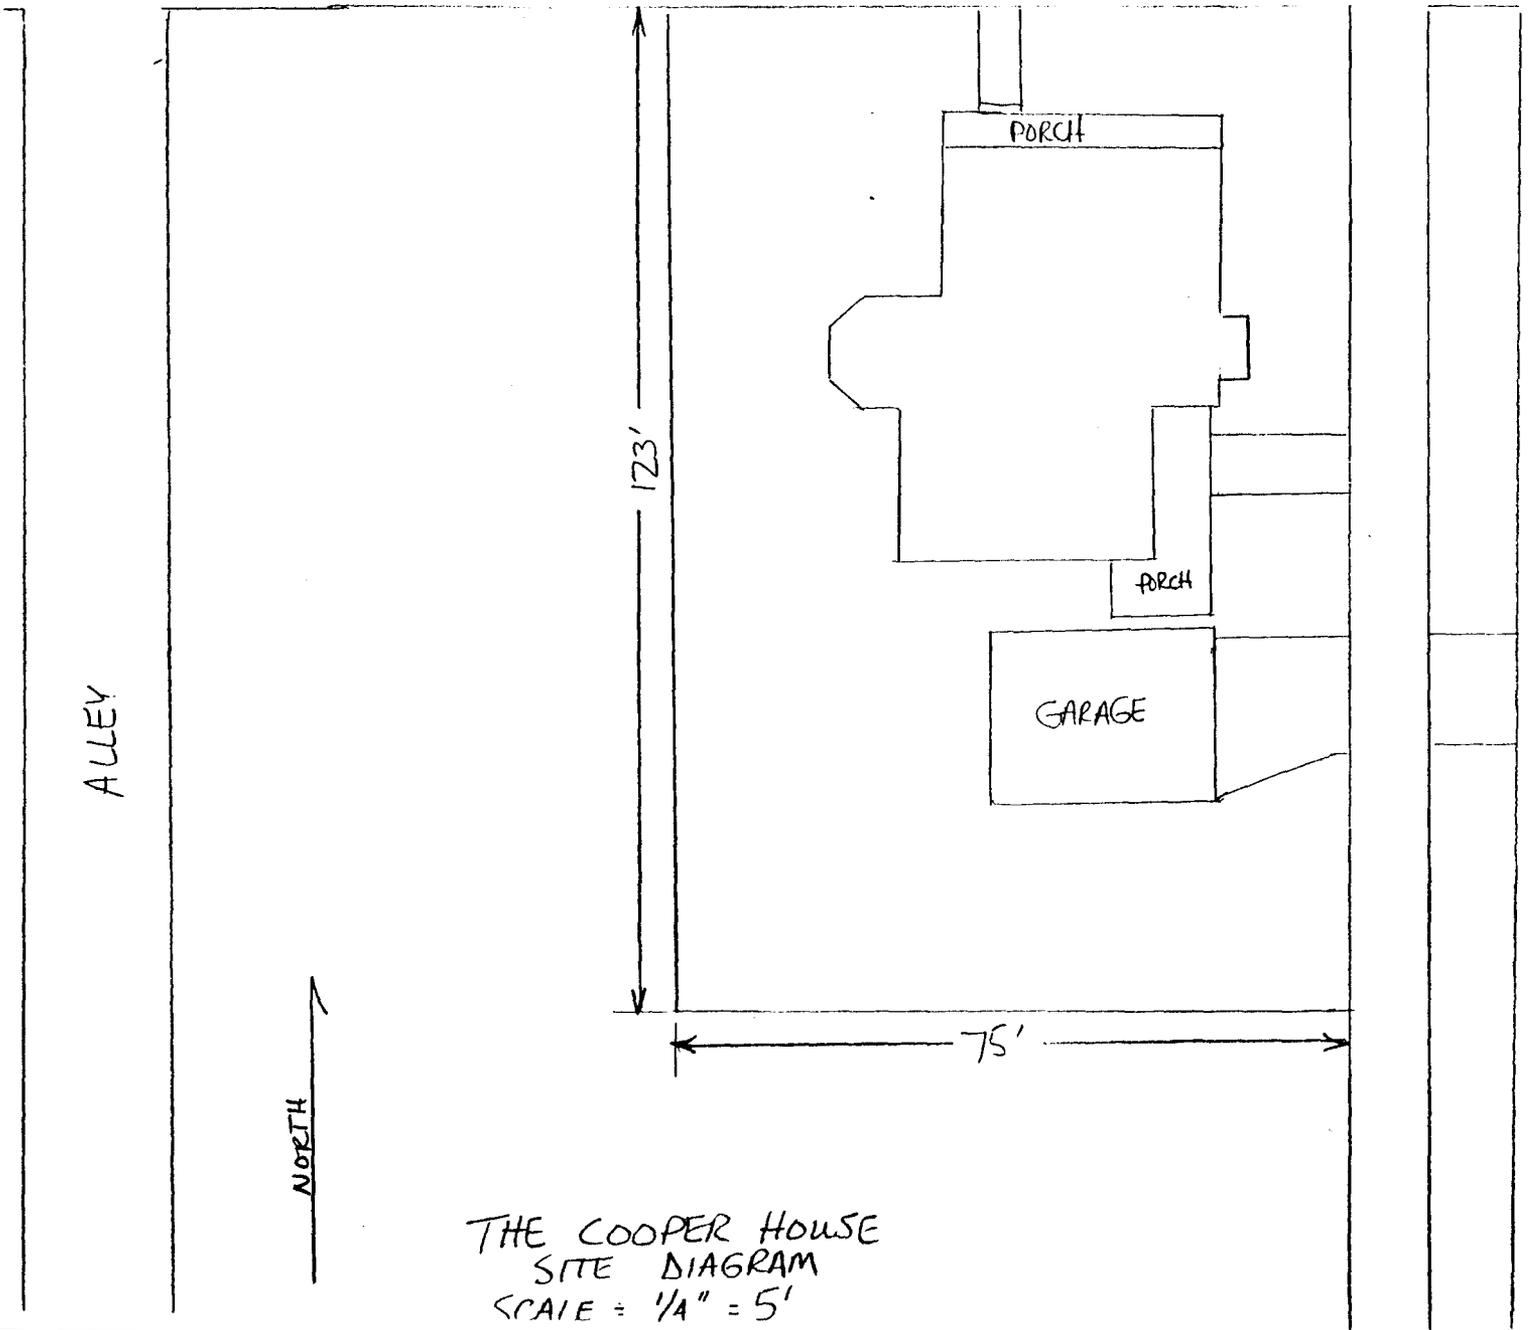
THE COOPER HOUSE
SITE DIAGRAM
SCALE = 1/4" = 5'

When the house was constructed in 1856, it was constructed centrally on a plot of land that measured 75 feet East to West and 160 feet North to South. In 1921, the Cooper family acquired the North 20 feet of Lot 7 which adjoins the original property to the South. In 1952, the South 37 feet of the East half of Lot 6 along with the North 20 feet of Lot 7 was sold and a small residence built on that parcel. The boundary description above is the remaining portion of the original plot of land upon which the building is located.

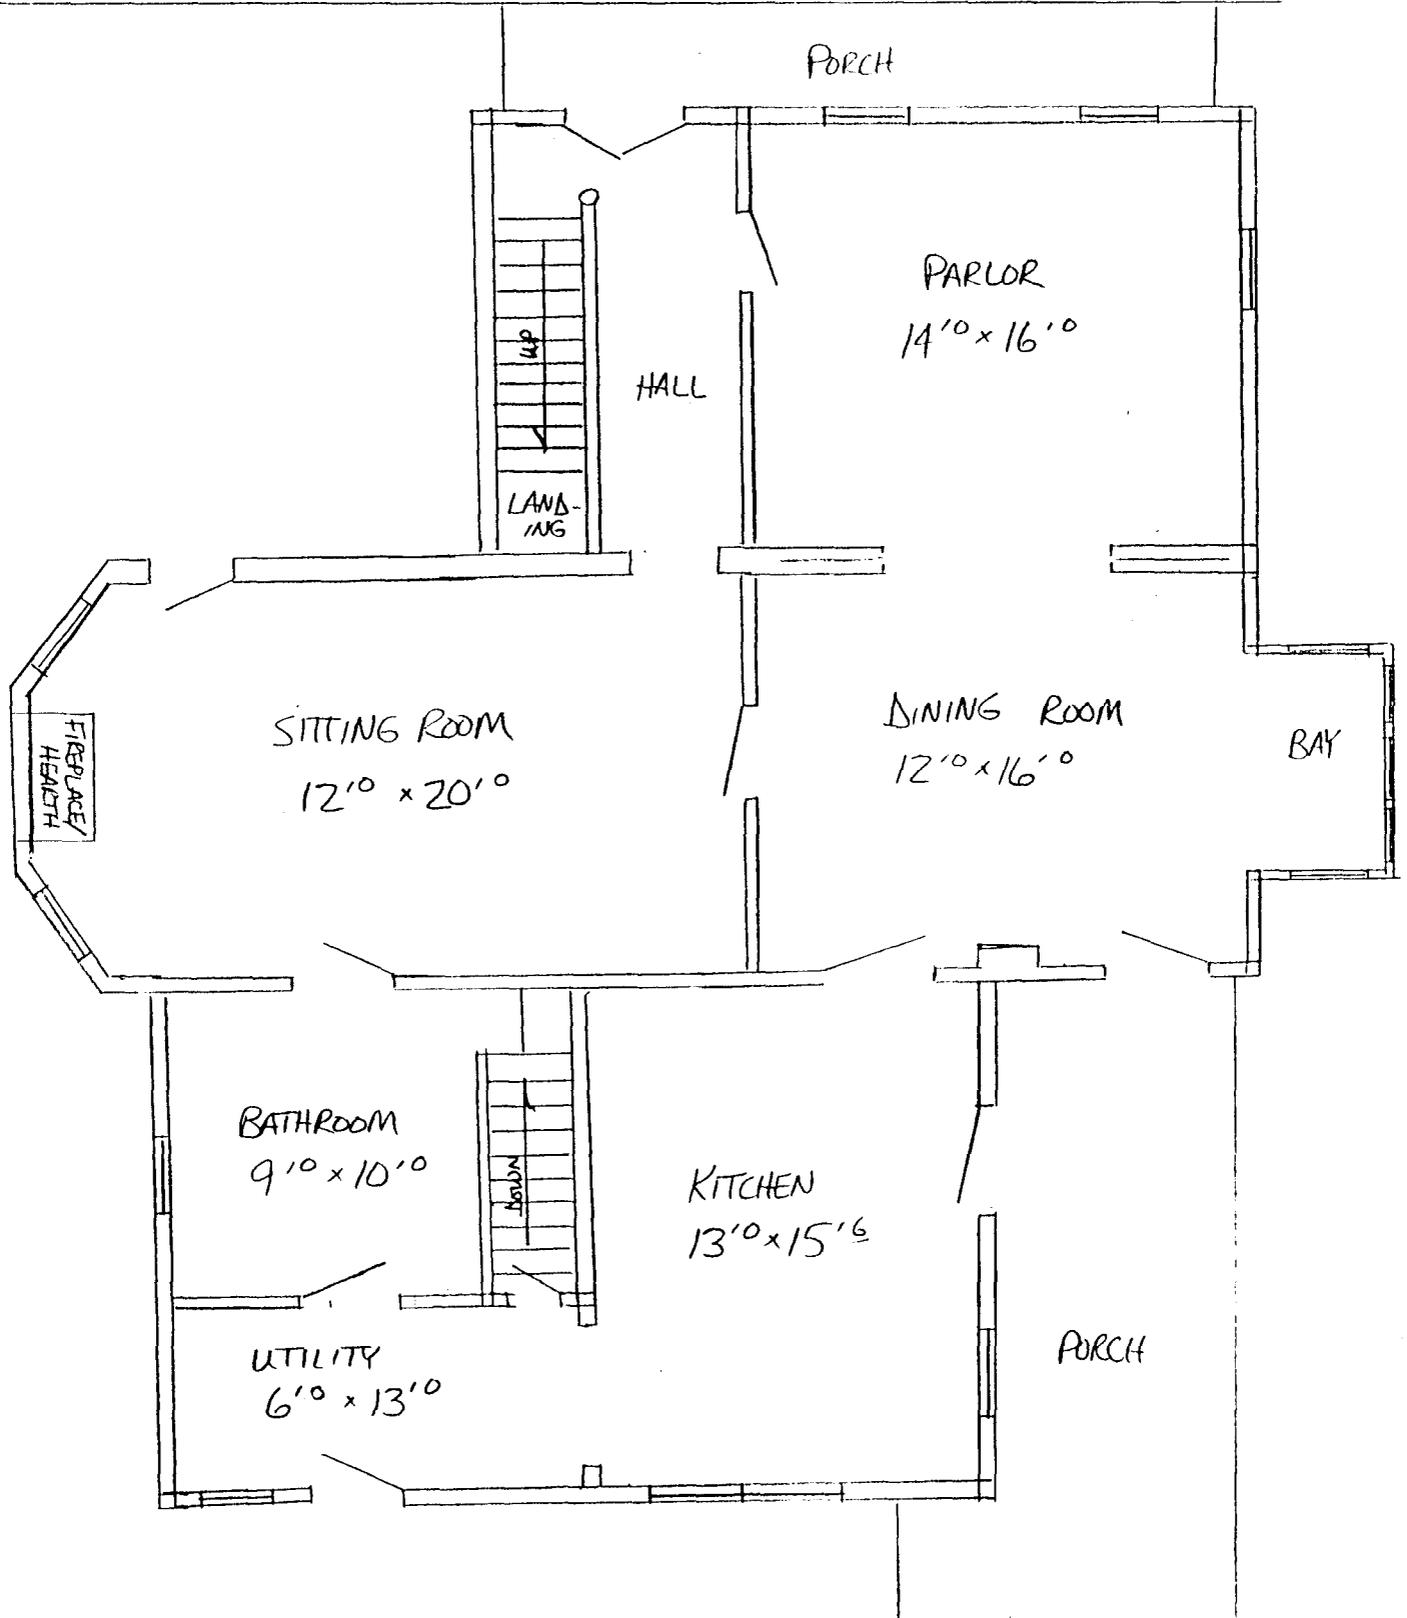
Floor Plan
Section number _____ Page 10 First Floor Plan Scale 1" = 6'

Inside, the Cooper House consists of an entryway, front parlor, dining room, sitting room, kitchen and bath on the first floor. Pocket doors separate the dining room and the front parlor. It has been determined that these doors were originally hanging doors but were later converted to pocket doors. This idea was reinforced when a wood wall was discovered under the existing wallpaper in the parlor. Three-inch tongue and groove boards make up this wall with each individual board numbered. The second floor consists of a hallway with a horseshoe staircase, three bedrooms, bath and a closet area. All of the original interior walls remain intact, with the load bearing walls all constructed of brick. Transoms are located over each of the first floor doorways. The woodwork throughout the house is pine and was all originally painted. The floors are pine also.

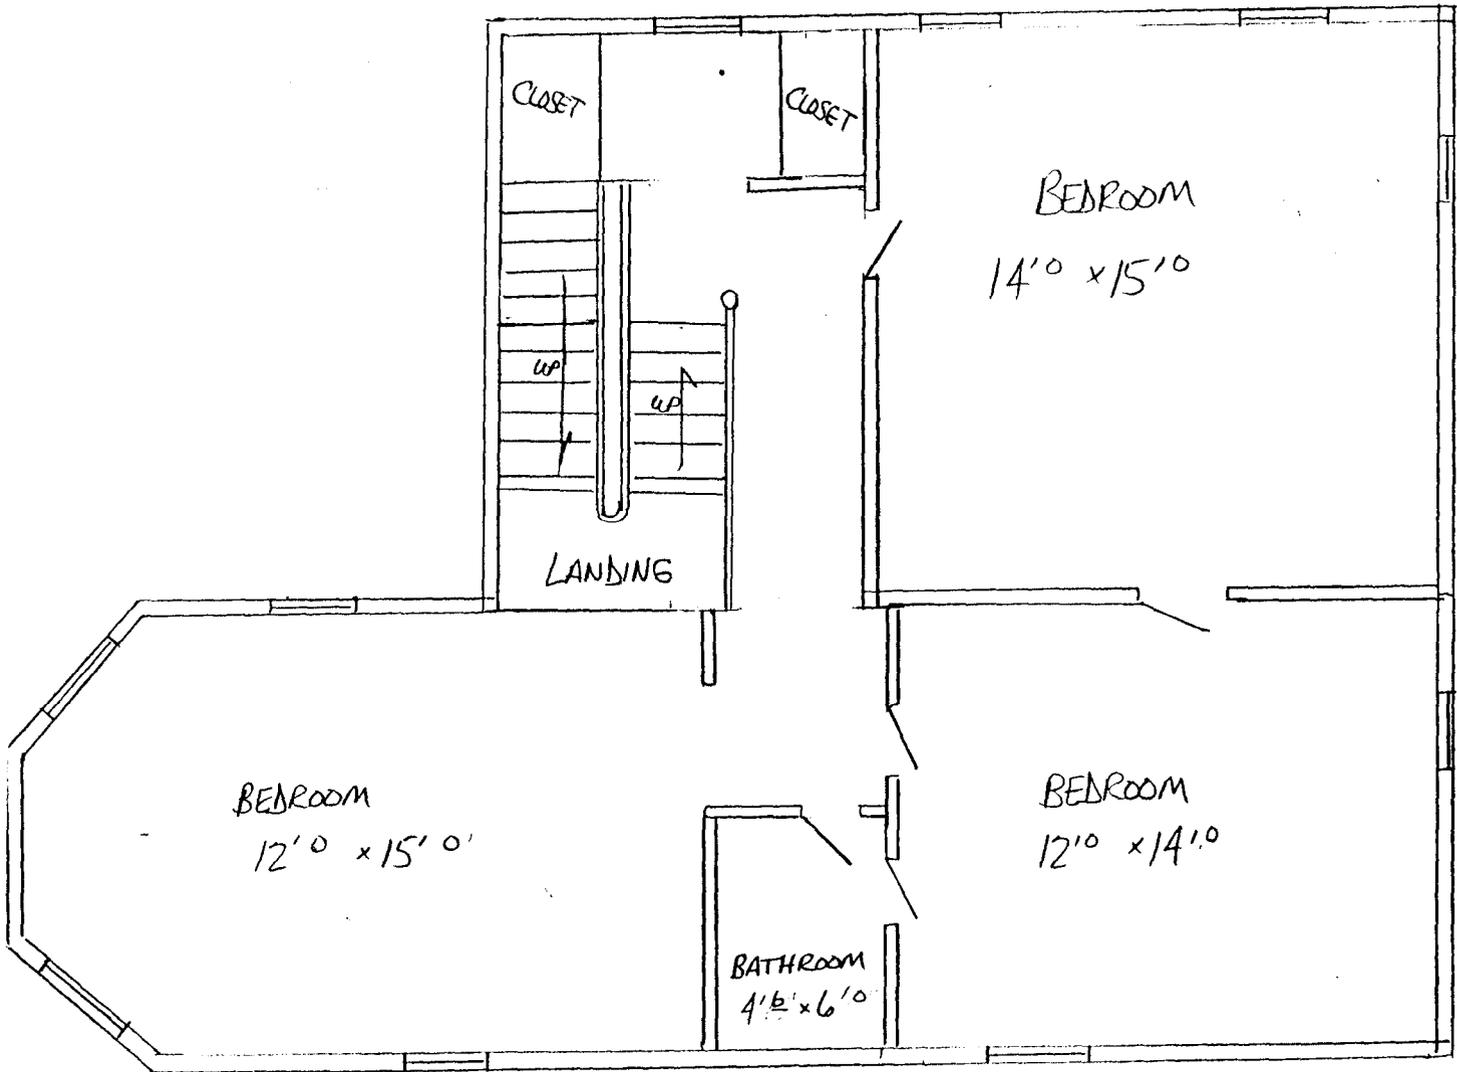
Second Floor Plan

Scale 1" = 5'
